Case Vehicle (A): 2002 Chevrolet	Vehicle (B): 2002 Dodge
Type: Trailblazer LT, 4-door SUV 4wd	Type: Durango, 4-door SUV 4wd
Driver: 54-year-old male	Driver: 47-year-old male
CDC: 12-FLEW-3, 00-RDAO-3	CDC: 12-FDEW-4

This is a fatal crash; the driver of case vehicle (A) was fatally injured in this severe offset-frontal crash.

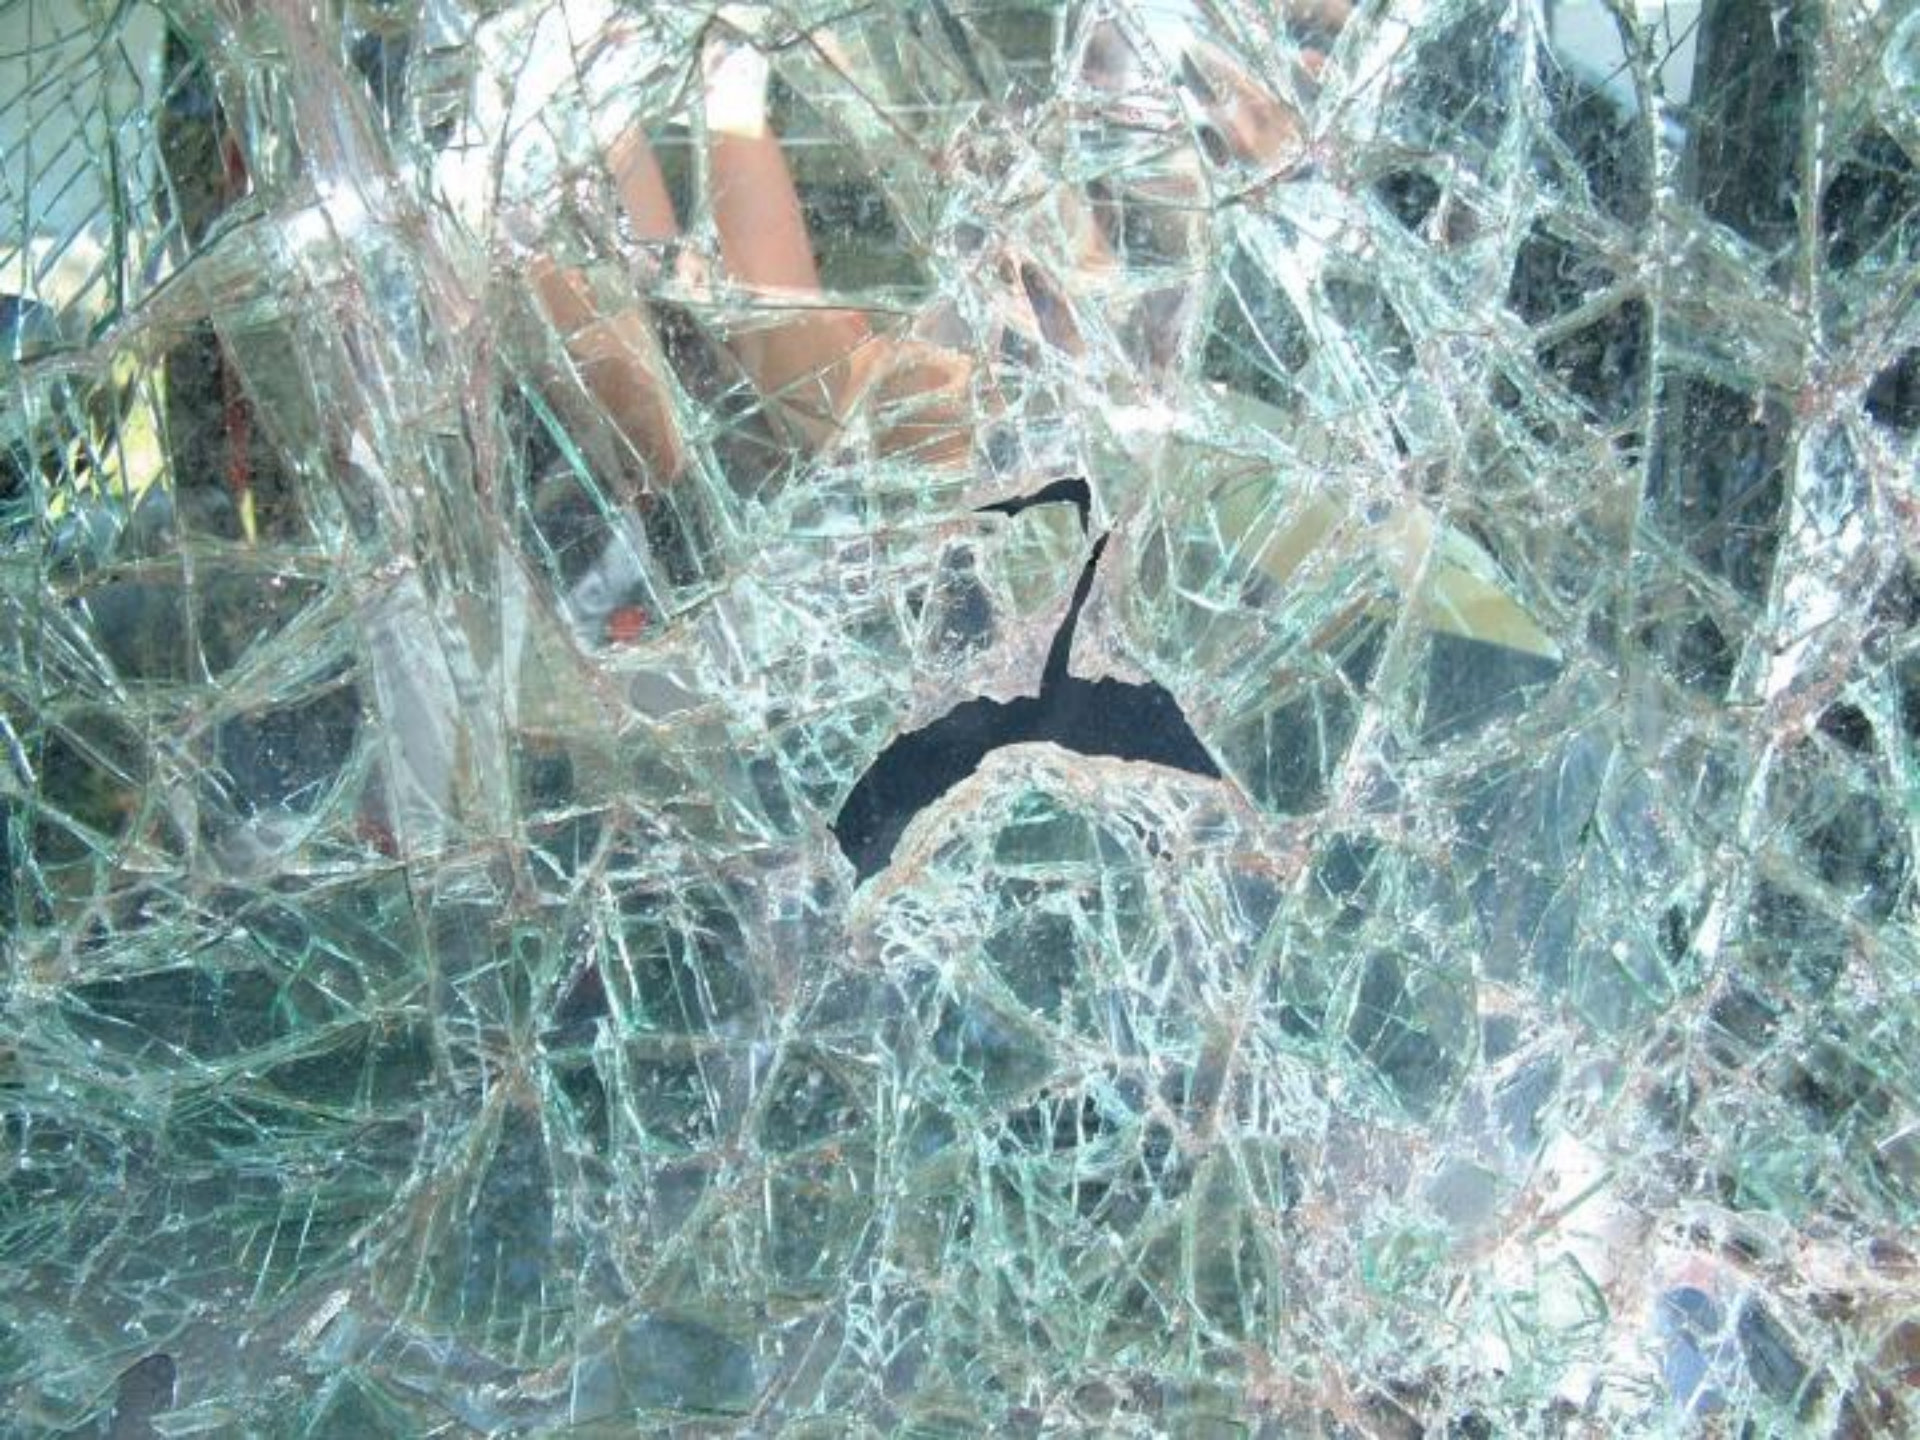
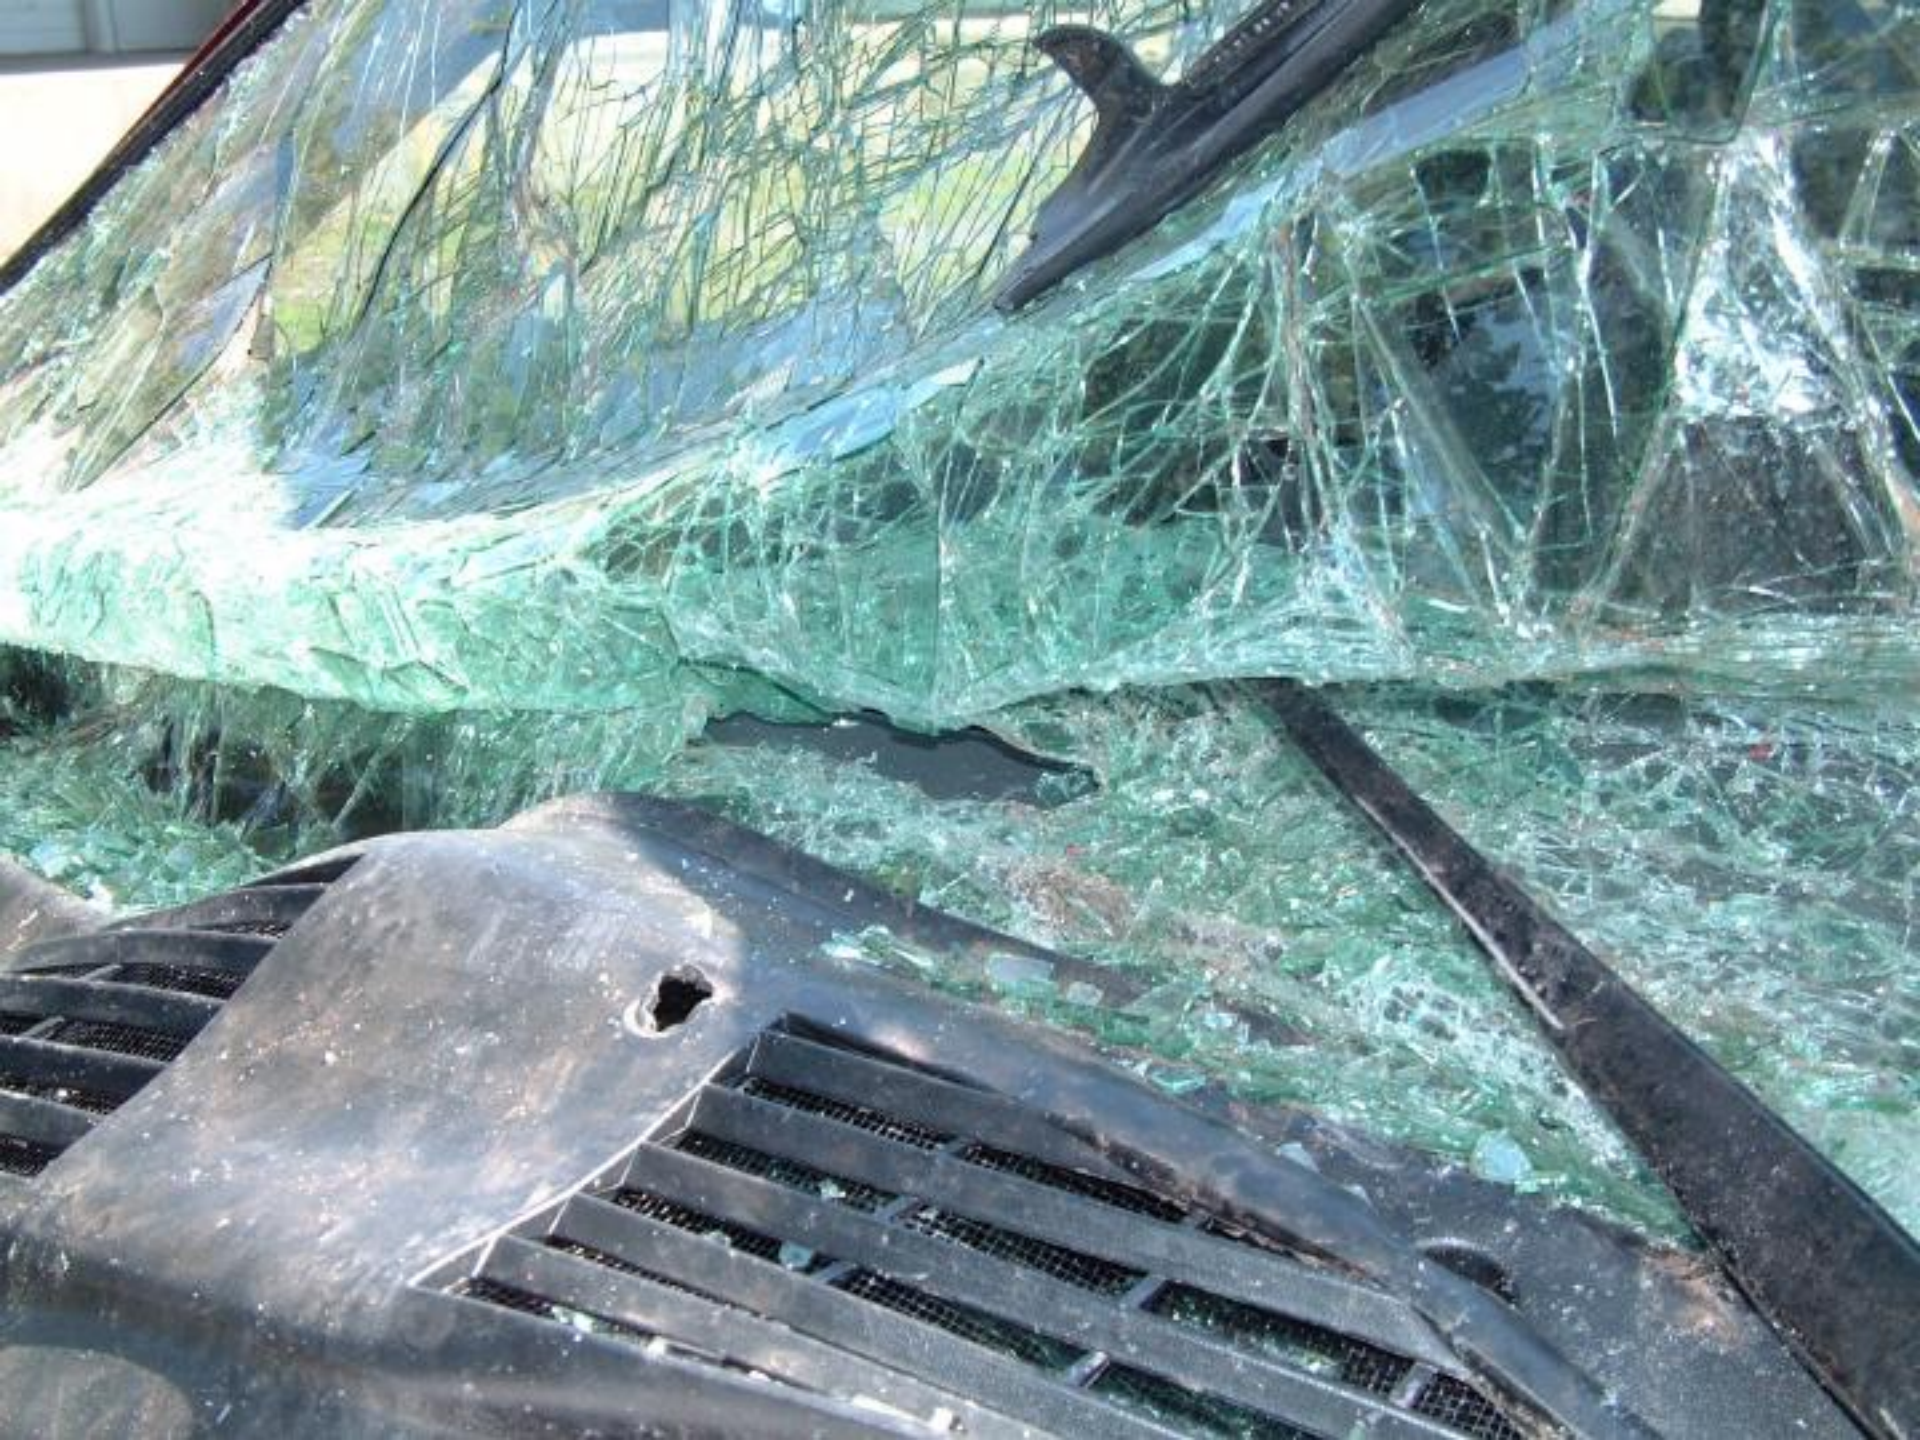
damaged from contact with the ground. [44](#) [45](#) There was no damage to the right wheels, although the right wheelbase was increased 3 cm. In addition, the right sideview mirror and the right-rear taillight and turn indicator light were broken. [46](#) [47](#) The most severe damage from the rollover was to the right quarter panel, which was crushed to the left. [48](#) At the rear of the vehicle, the right-rear tailgate was damaged and the rear backlight glass was broken.

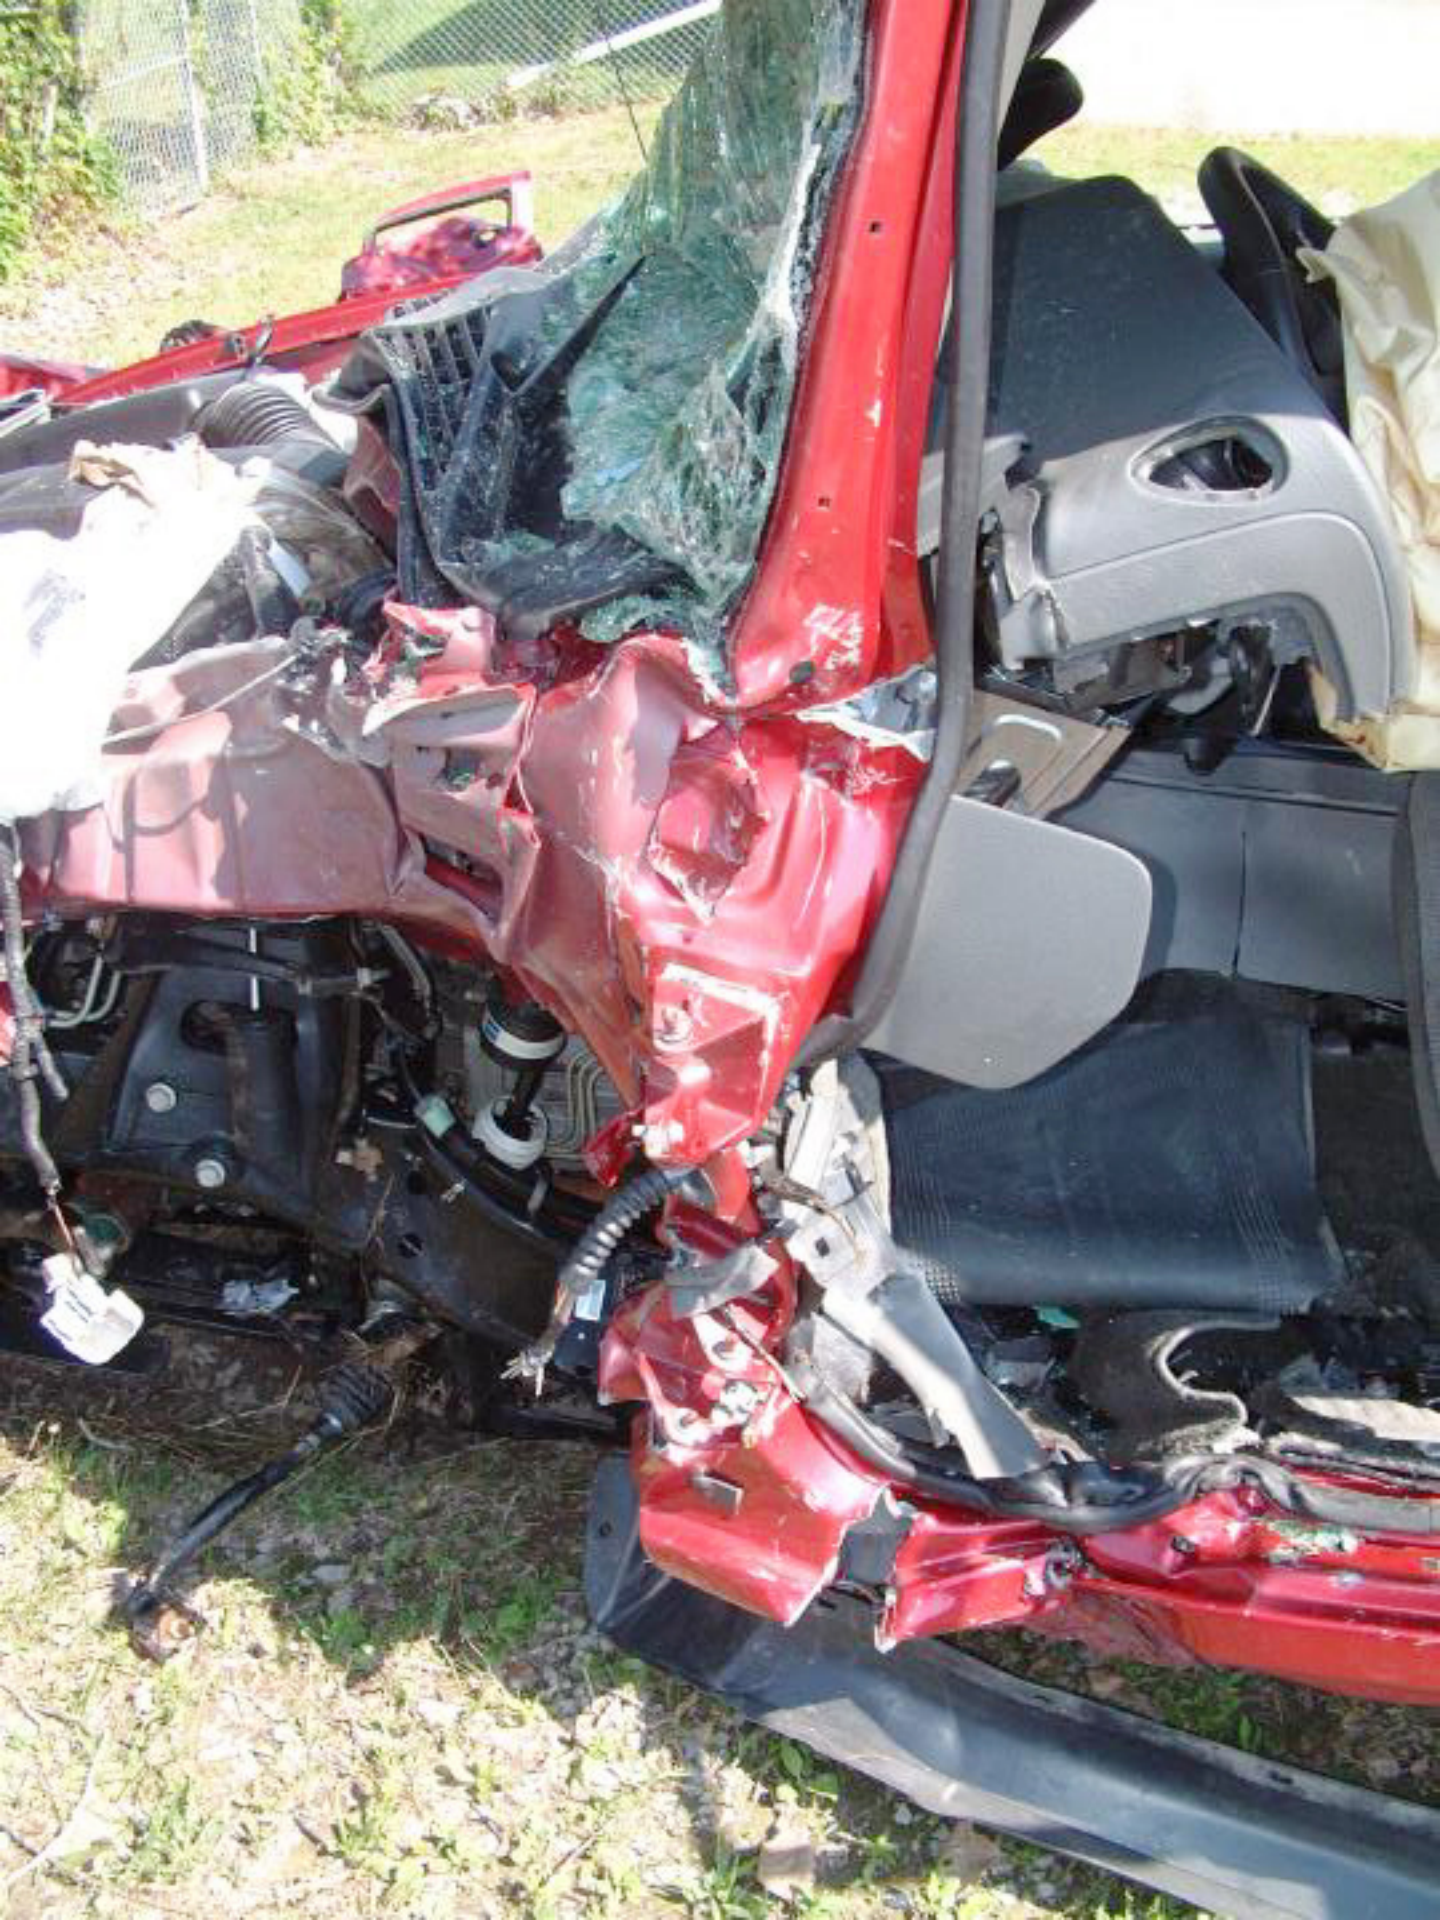
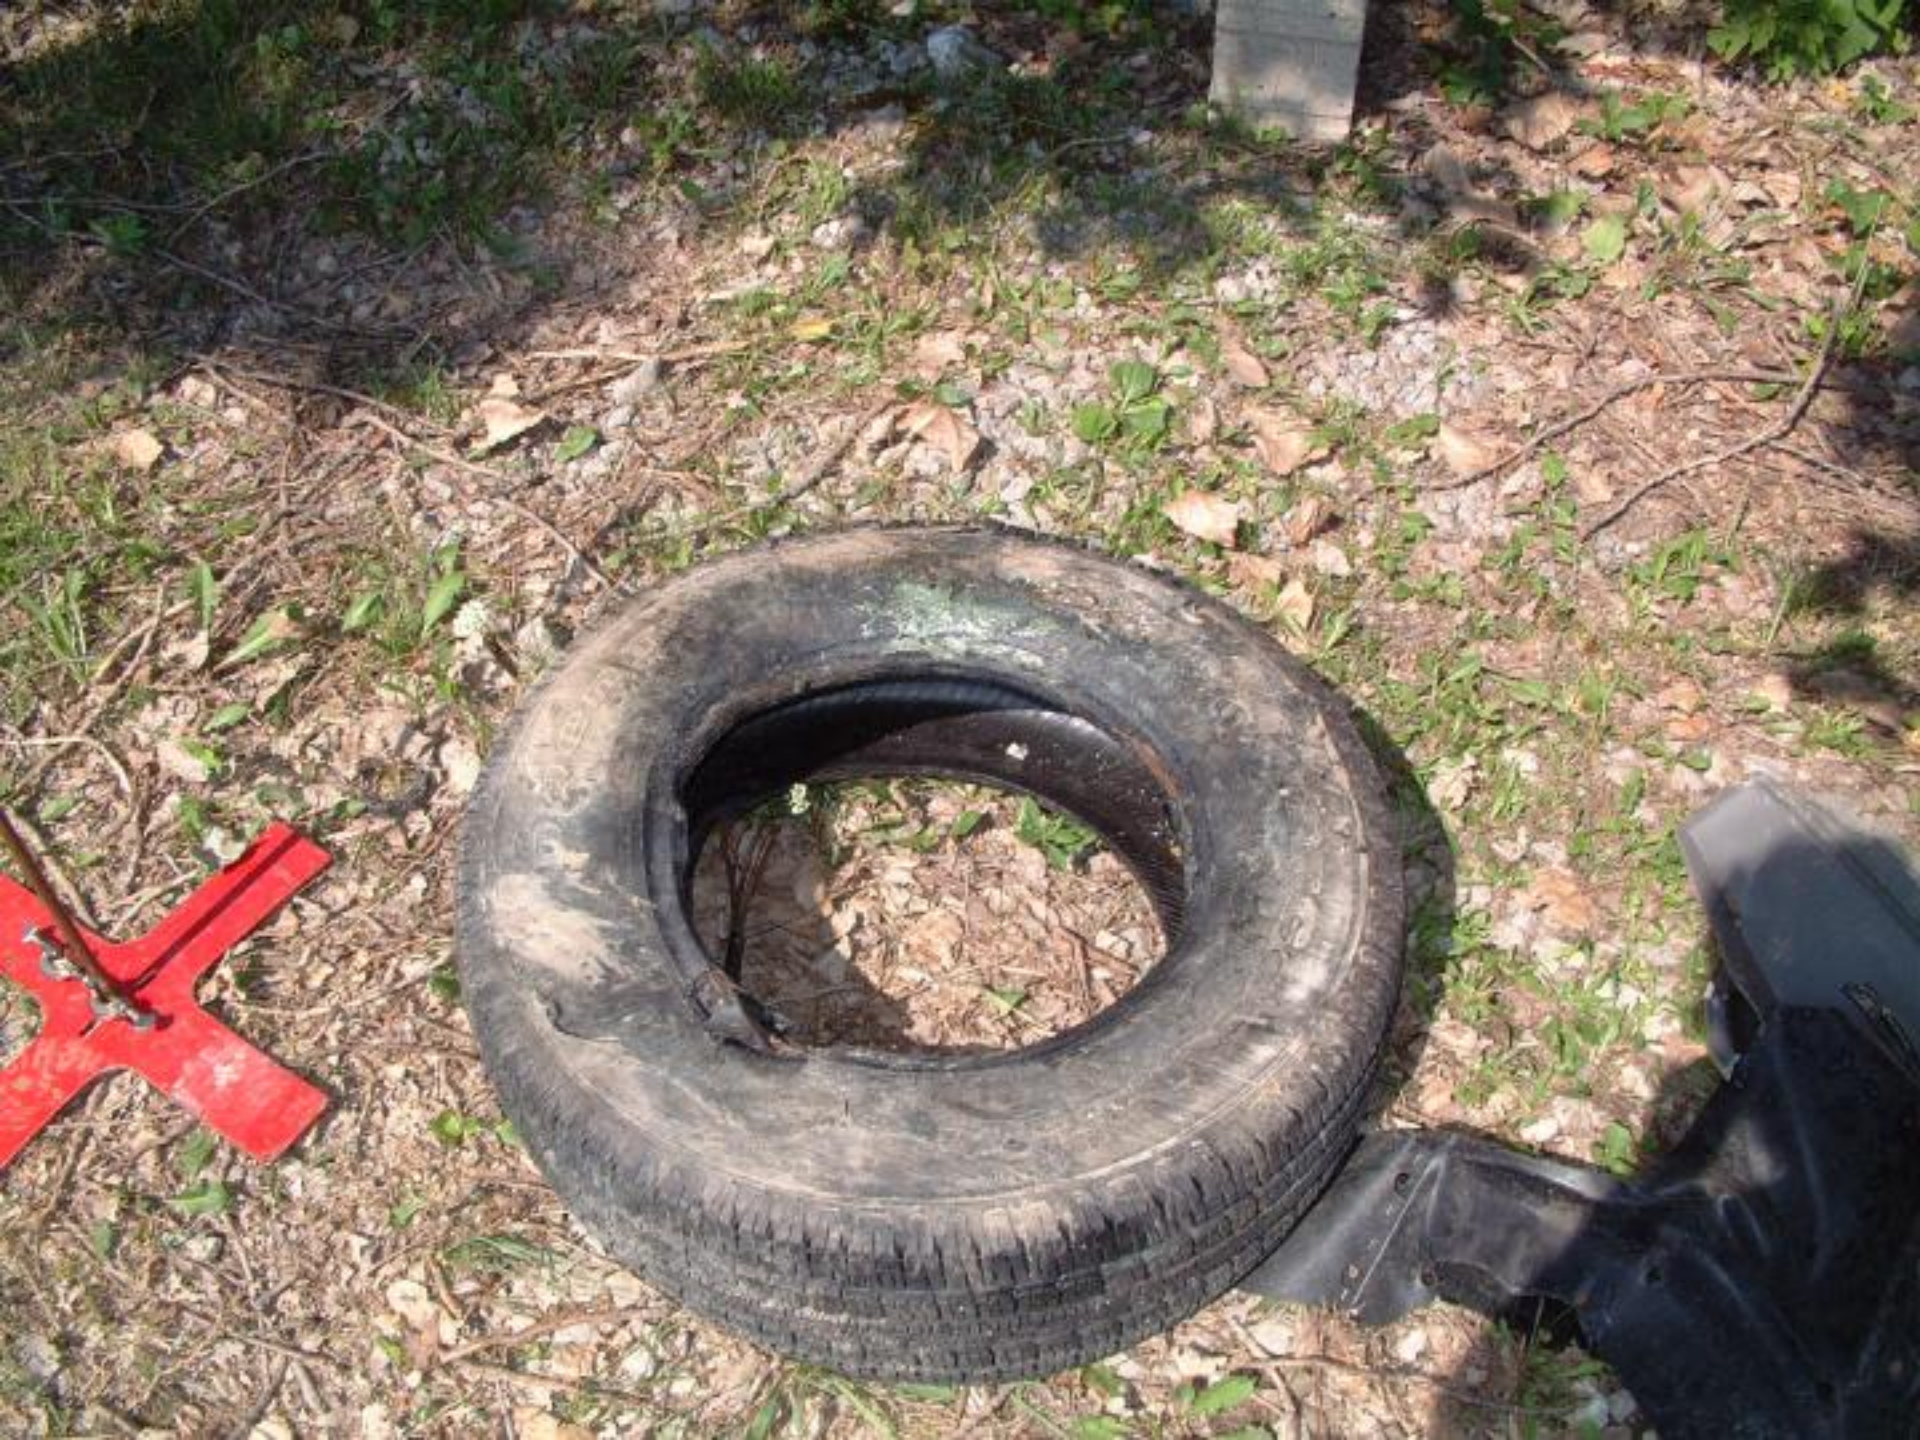
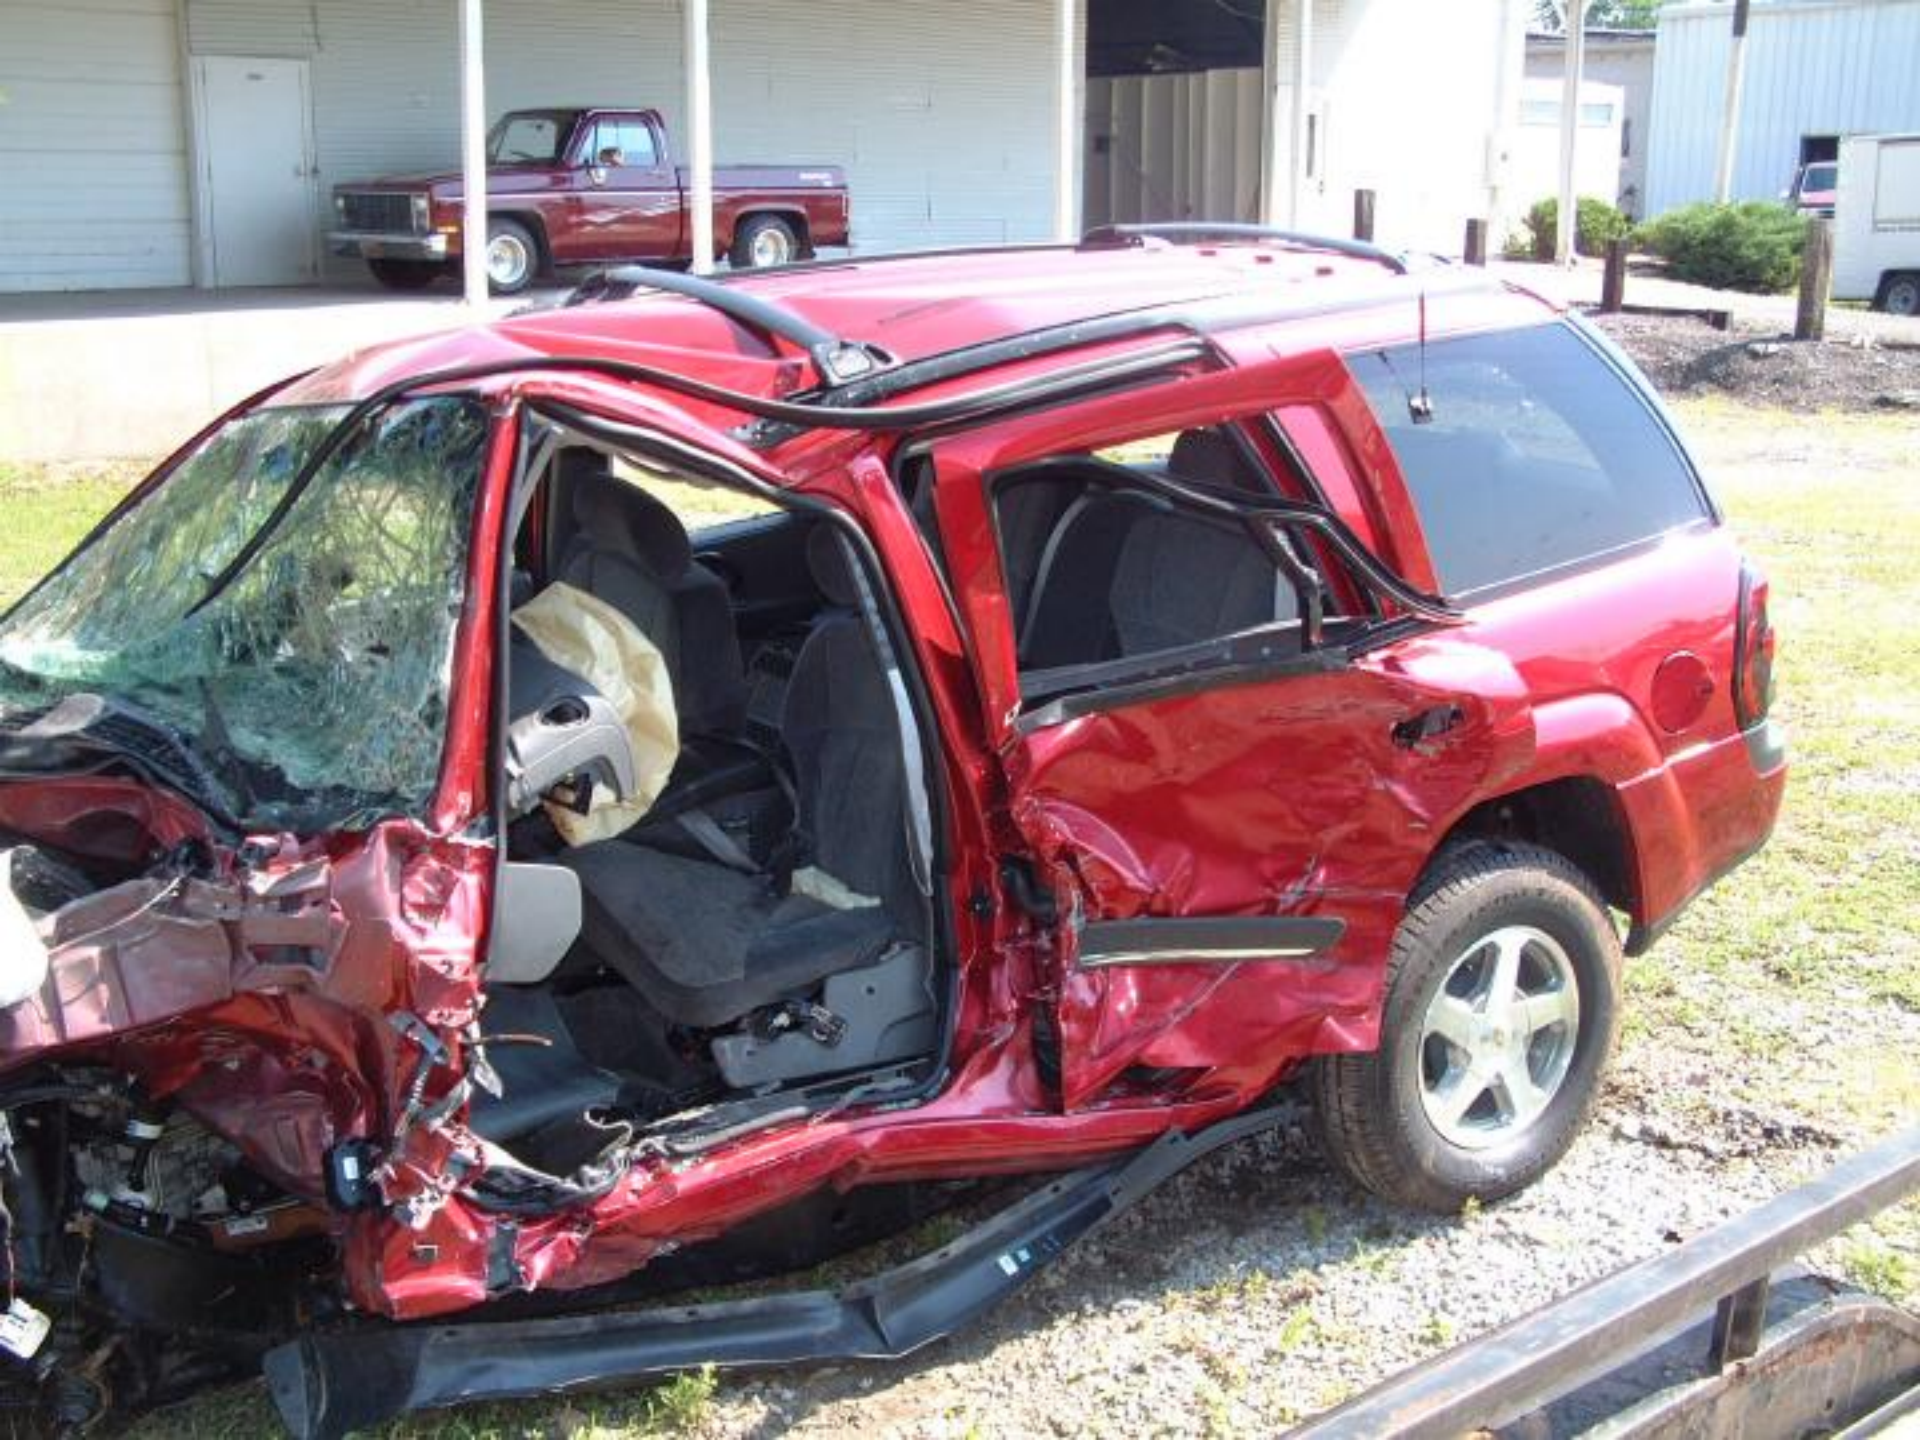
[49](#) This vehicle was equipped with steering-wheel [50](#) and passenger frontal-impact airbags, and both deployed during the severe offset-frontal impact. [51](#) It was also equipped with side-impact airbags, which did not deploy. [52](#) There was no visible damage to, or contact marks on, the driver airbag, but it was covered with blood. [53](#) [54](#) [55](#) The steering-wheel rim and spokes were severely bent and the upper half of the rim was pushed forward into contact with the upper instrument panel. [56](#) In addition, the steering column was deflected up and to the right. [57](#) The interior of the left side of the windshield was damaged throughout, the windshield header was damaged, the sunvisor was deformed, [58](#) and the interior trim over the left A-pillar was displaced. [59](#) The roof in the driver area was also crushed down and the roof siderail was damaged. [60](#) The upper and mid portions of the instrument panel in the driver area were displaced to the rear and damaged. The driver knee bolster was damaged and the cover was dislodged from its mount. Also in the driver area, the kickpanel, [61](#) the interior of the driver door, the door hardware, and the door armrest were damaged. [62](#) The door window frame was crumpled and [63](#) [64](#) the B-pillar cover was separated and pushed to the right. [65](#) The toepan, floor, [66](#) and foot controls in the driver area were also damaged and displaced to the rear. [67](#) The driver seatback and seat cushion were damaged from lateral intrusion of the door, and the seat was rotated to the right.

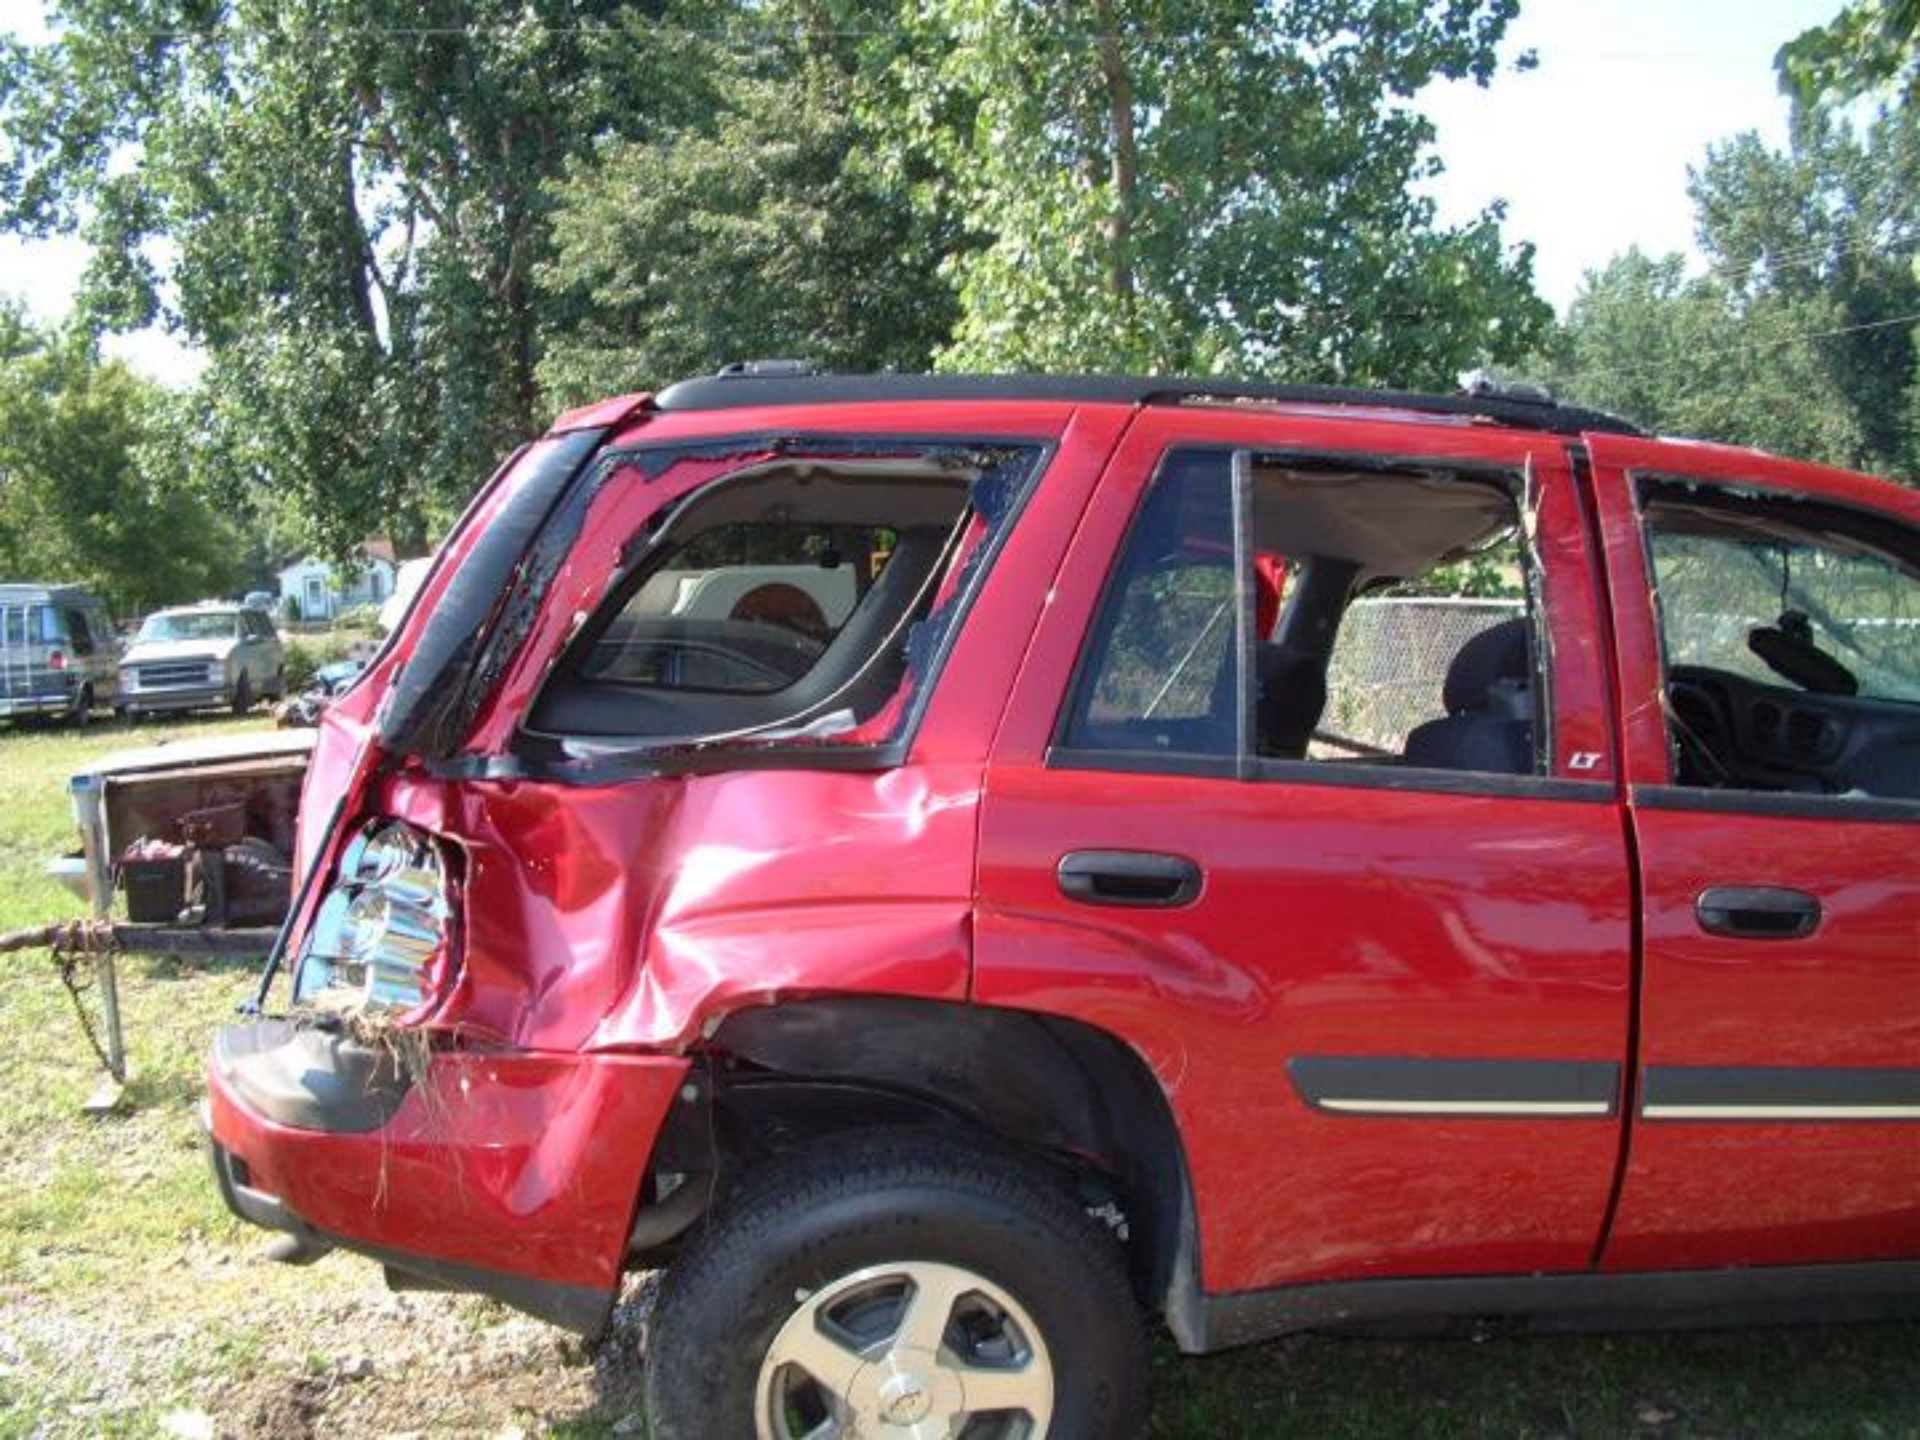
[61](#) He sustained unspecified antero-central and bilateral posterolateral pelvic fractures, probably from hip contact with the interior of the driver door, and he sustained left radius and ulna fractures with multiple left forearm and arm lacerations and contusions, possibly from forearm contact with the left A-pillar or the interior of the driver door. He sustained a fracture to the left humerus and lacerations to the left shoulder, probably from contact with the interior of the driver door.

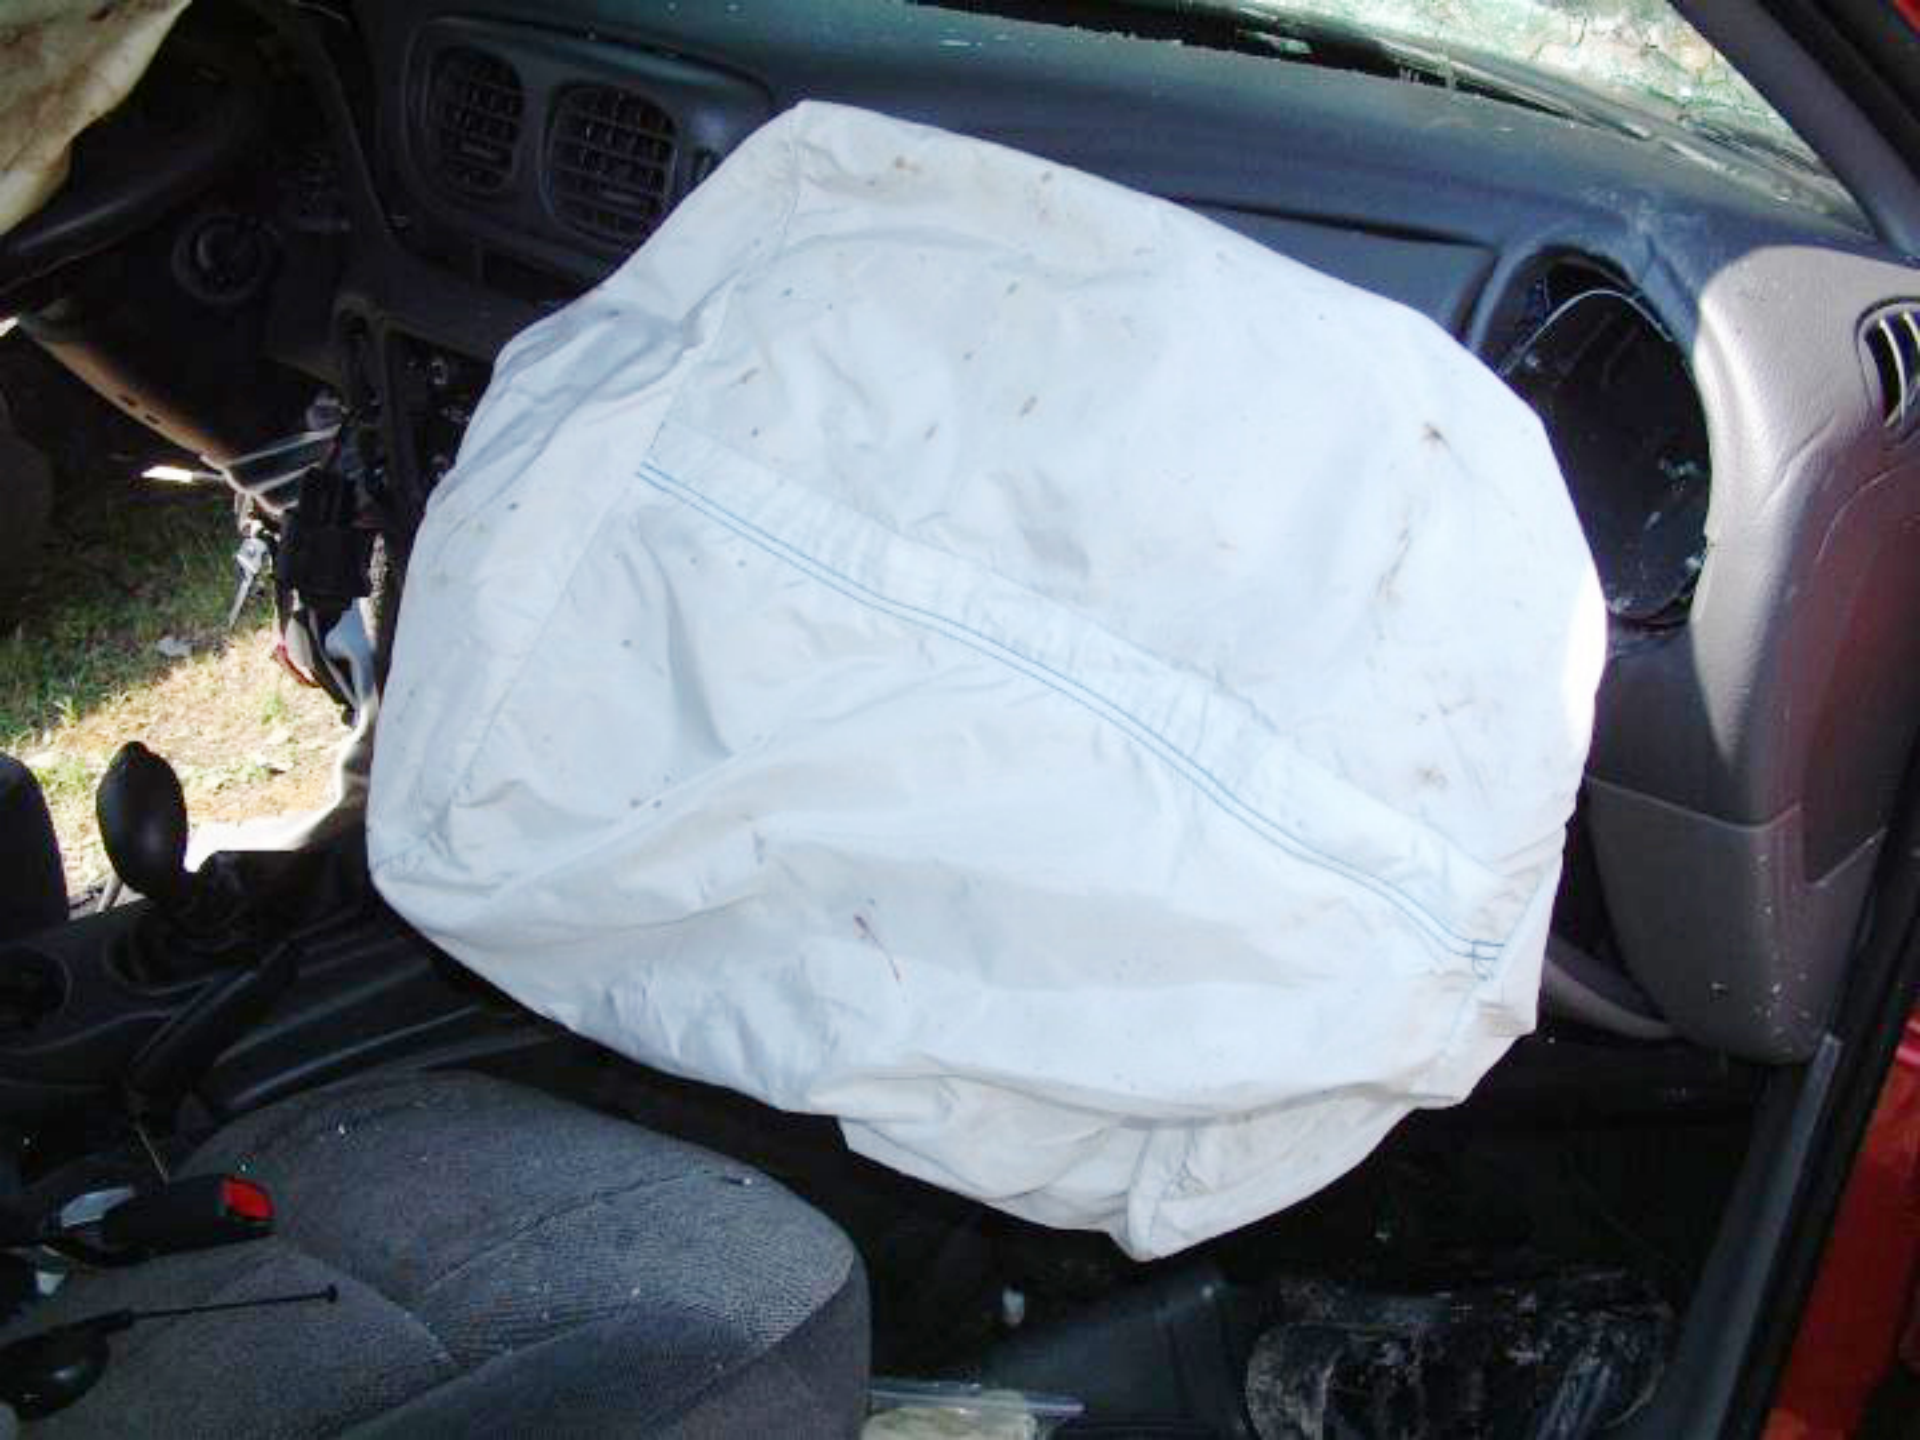
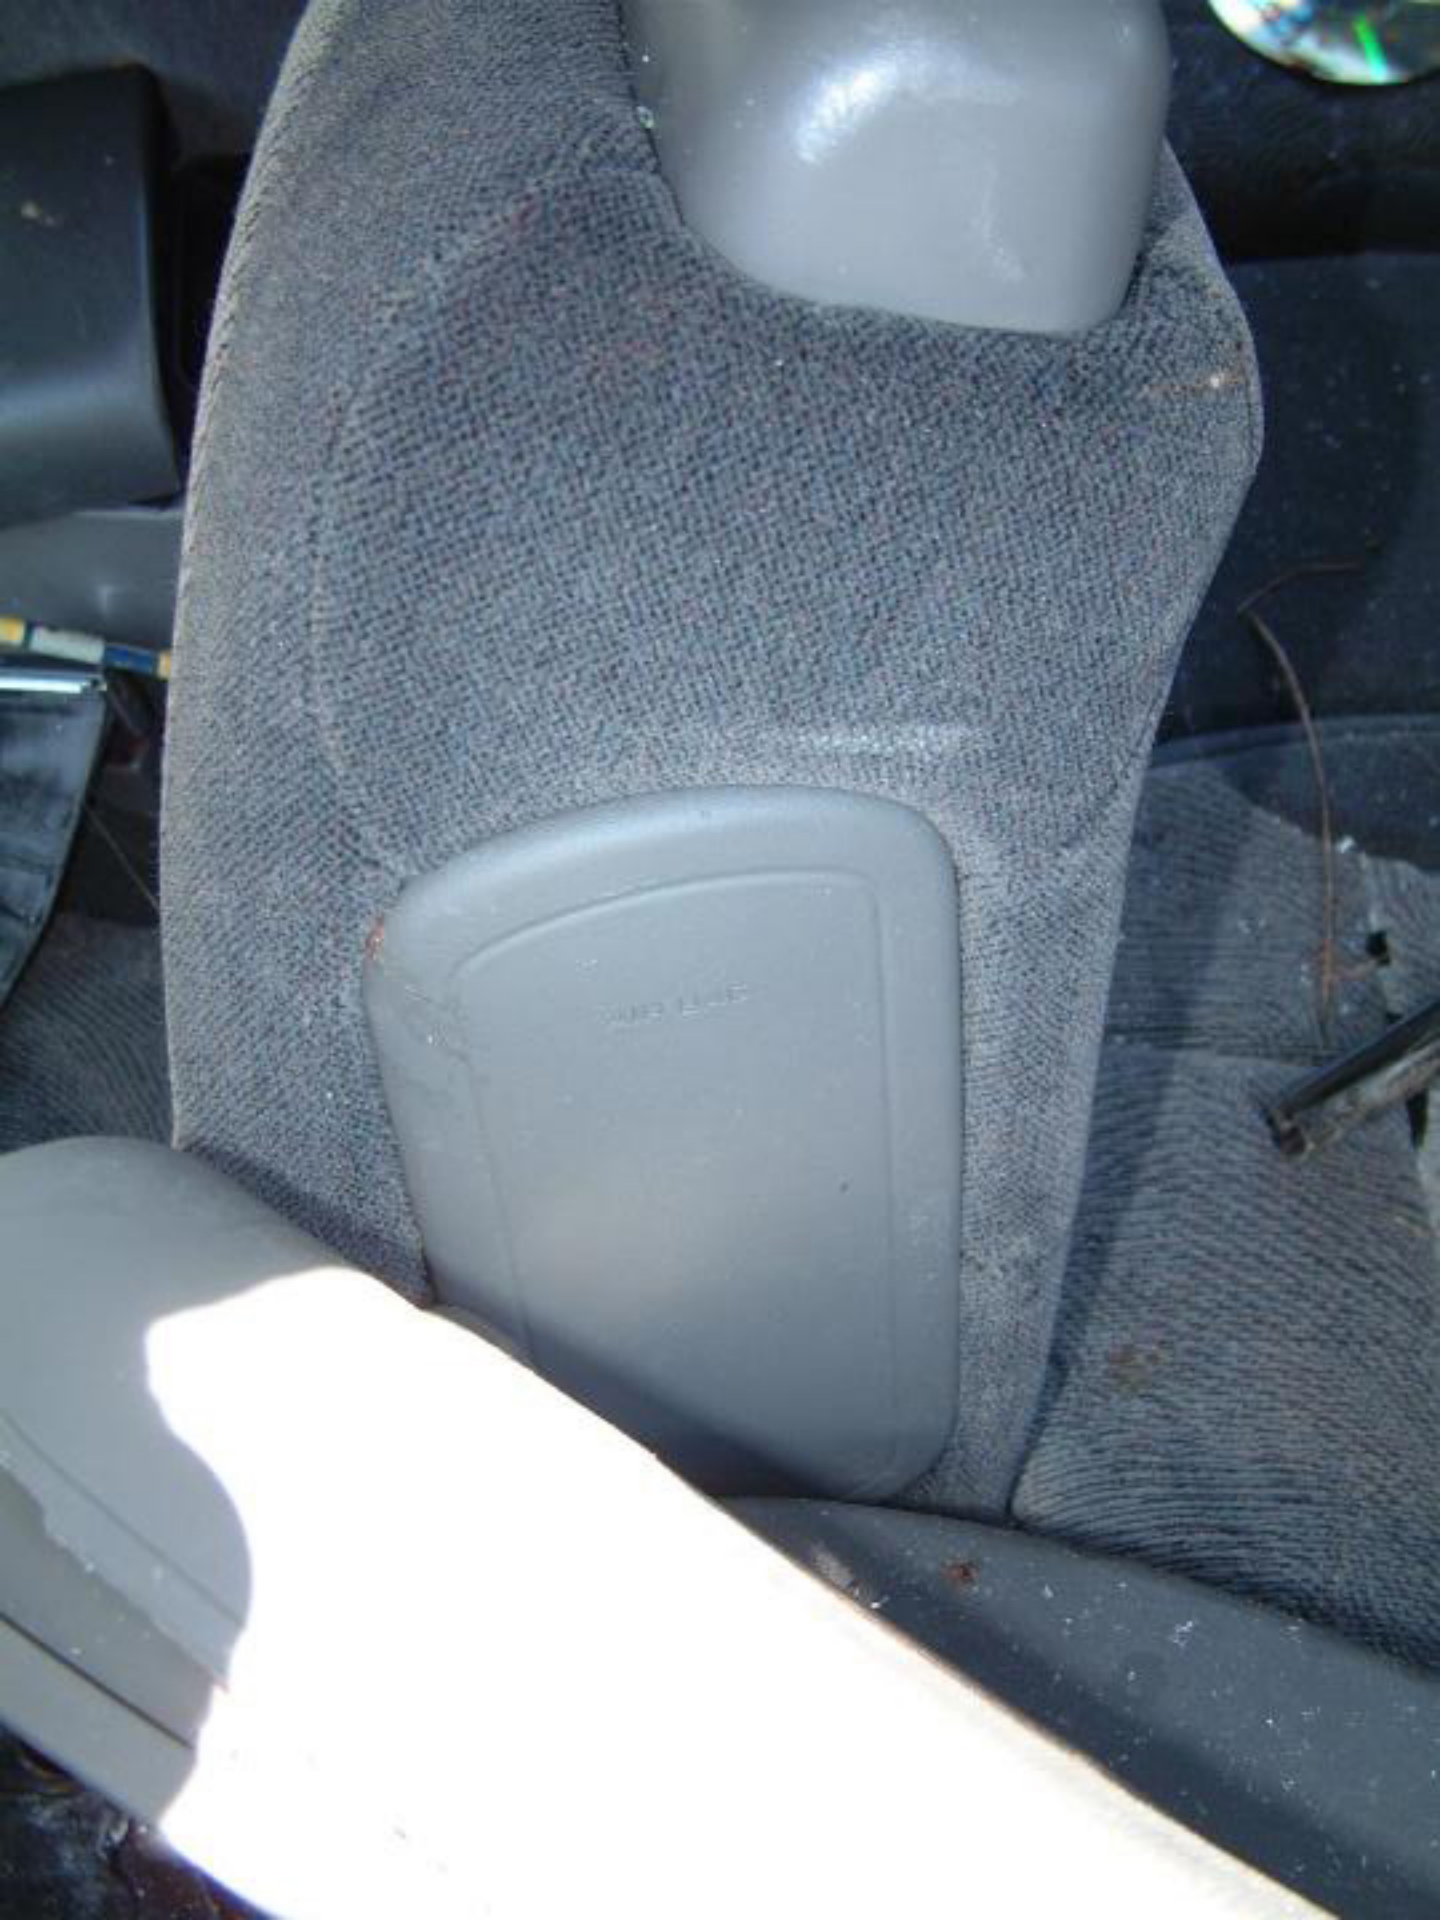
[68](#) The center portion of the roof was buckled, the center portion of the windshield glass was broken, and the center rearview mirror was separated from the windshield, but the mirror glass was not broken. [69](#) All components on the center portion of the dashboard were damaged and displaced to the rear, including the ashtray, control knobs, and vents and ducts. [70](#) The center console was damaged and the center armrest between the seats was deflected to the right.
